Manhole Inspection Summary

Manhole # S25II_036MH

Insp Date: **8/29/07 10:24 AM**

Location Address: **434 BLOOM ST**

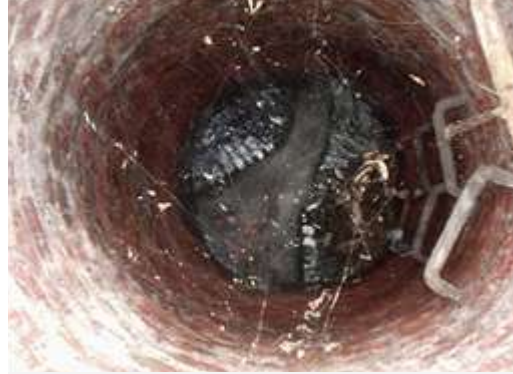
Top View

Corroded steps. Evidence of surcharge - Bench debris.

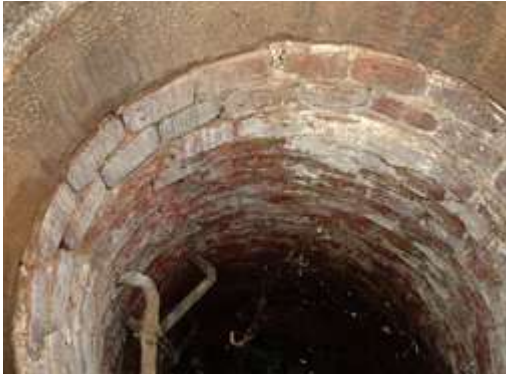
Defect

Frame leaks. Adjustment deterioration and infiltration. Barrel infiltration - other side.

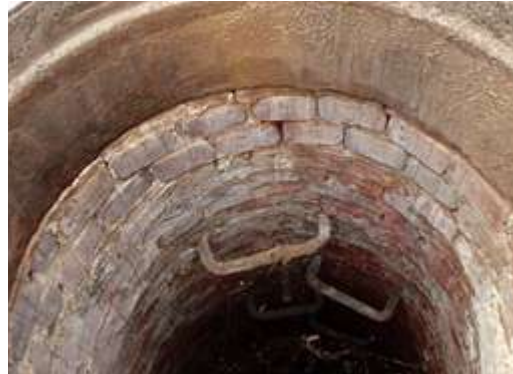
Defect

Frame leaks. Adjustment deterioration and infiltration. Barrel infiltration.

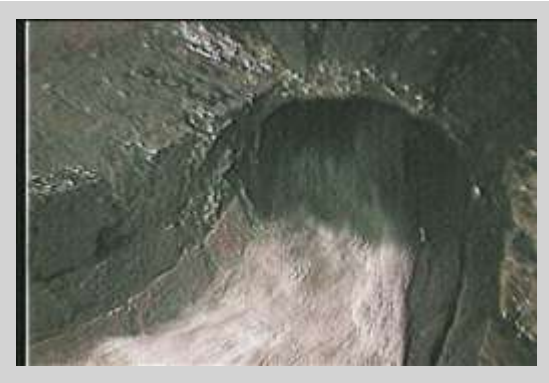
10 in. Circular Gravity Sewer Pipe Out @ 12 O'Clock

Pipe Material: **Clay** ☐ Pipe Lined

Invert Depth: **12.80** (ft.) Flow Characteristics: **Fast**

Infiltration: **None** Pipe Seal Cond: **Unknown**

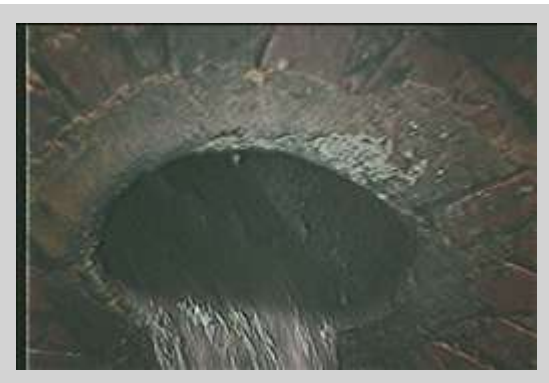
8 in. Circular Gravity Sewer Pipe In @ 6 O'Clock

Pipe Material: **Clay** ☐ Pipe Lined

Invert Depth: **10.80** (ft.) Flow Characteristics: **Fast**

Infiltration: **None** Pipe Seal Cond: **Unknown**

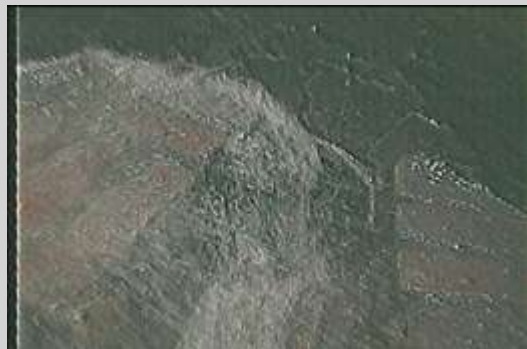
Pipe In @ 8 O'Clock

Pipe Material: **Clay**

Invert Depth: **12.60** (ft.) Flow Characteristics: **Fast**

Pipe Seal Cond: **Cracked**
